Test Report

Issue 1 Our Ref: GBW Date 08/03/2019 Page 1 Number 19-01187-2 of

Tested For:-A KENRICK & SONS LTD

SALT SPRAY TESTING OF DOOR HARDWARE SAMPLE

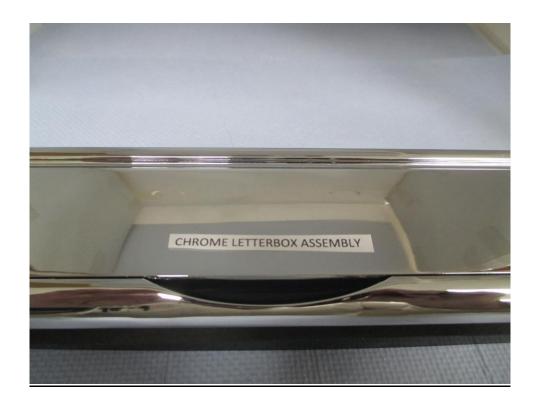
<u>FIG 1</u>

The photograph in fig 1 is showing the as-received condition of the sample prior to test, the sample was then exposed to a neutral 5% Salt Spray for a test period of 480 – 1008 hours with examinations after every 24 hours, revealed the following observations:-

Photograph showing the condition of the Chrome Letterbox Assembly prior to Salt Spray Test

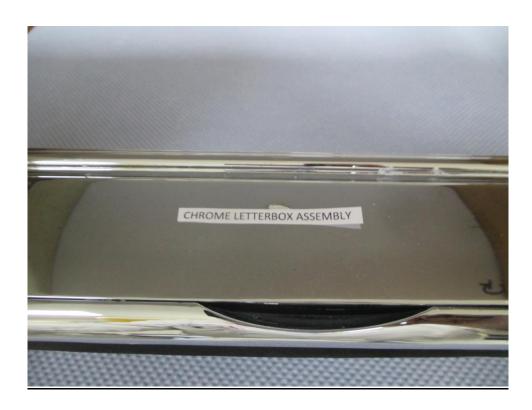
<u>FIG 2</u>

The flap section showed isolated corrosion spots and leaching white corrosion product / staining from the channel recesses.

The outer frame section showed no evidence of white corrosion product / staining, (see photograph after 96 hours).

Photograph showing the condition of the Chrome Letterbox Assembly after 96 hours Salt Spray Test

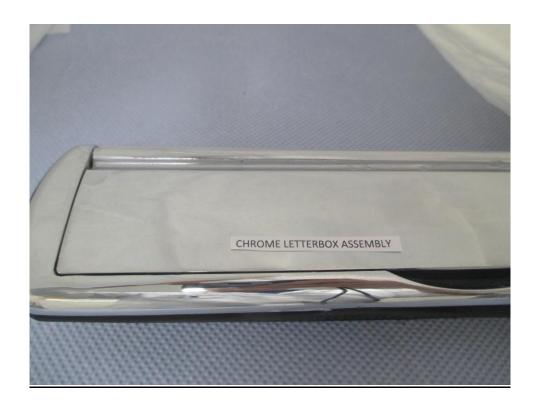
<u>FIG 3</u>

The flap section showed 6 x corrosion spots (maximum size 0.5mmØ) and leaching white corrosion product / staining from the channel recesses.

The outer frame section showed a slight amount of white corrosion product / staining from the edges, (see photographs after 264 hours).

Photograph showing the condition of the Chrome Letterbox Assembly after 264 hours Salt Spray Test

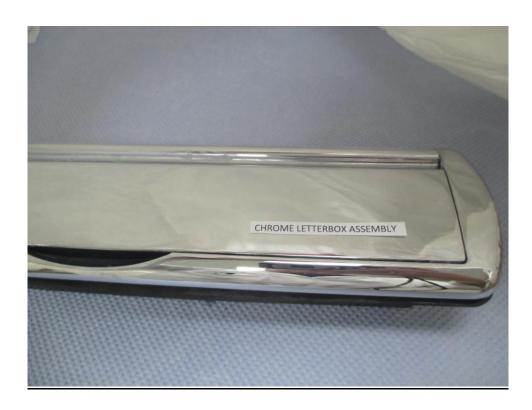
FIG 4

Photograph showing the condition of the Chrome Letterbox Assembly after 264 hours Salt Spray Test

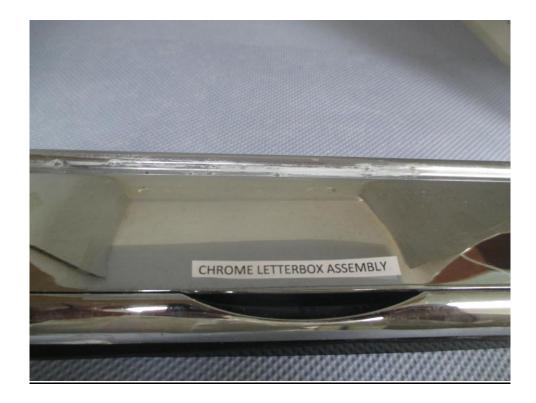
<u>FIG 5</u>

The flap section showed 6 x corrosion spots and leaching white corrosion product / staining from the channel recesses less than 1.5mm.

The outer frame section showed a moderate amount of white corrosion product / staining from the edges, (see photograph after 480 hours).

The finish applied to the Chrome Letterbox Assembly (Appearance) tested, <u>satisfied</u> 480 hours Salt Spray Test Requirement to British Standard Specification, BS EN.1670:2007, Grade 5.

Photograph showing the condition of the Chrome Letterbox Assembly after 480 hours Salt Spray Test

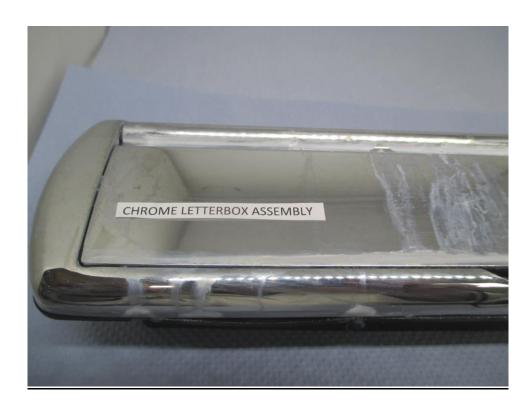
<u>FIG 6</u>

The flap sample showed evidence of 10 x corrosion spots (maximum size $3.0 \text{mm } \emptyset$) and leaching white corrosion product / staining from the small channel recess and 1 x corrosion spot ($4.0 \text{mm } \emptyset$) and leaching white corrosion product / staining from the large channel recess, the flap exhibited significant staining product from corrosion spots from the channel recesses.

The outer frame sample showed a significant amount of white corrosion product / staining from the end interface joint, the outer frame edges showed white corrosion product / staining from the underside of the sample, (see photographs after 1008 hours).

Photograph showing the condition of the Chrome Letterbox Assembly after 1008 hours Salt Spray Test

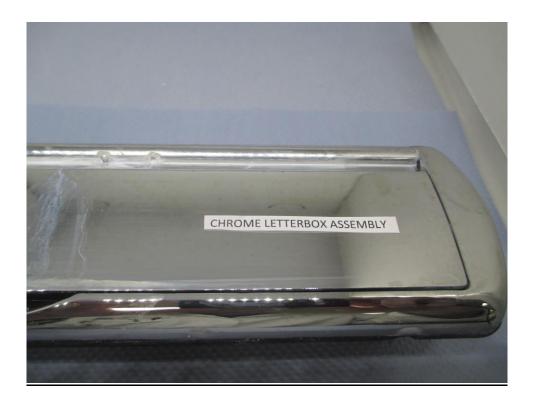
<u>FIG 7</u>

Photograph showing the condition of the Chrome Letterbox Assembly after 1008 hours Salt Spray Test

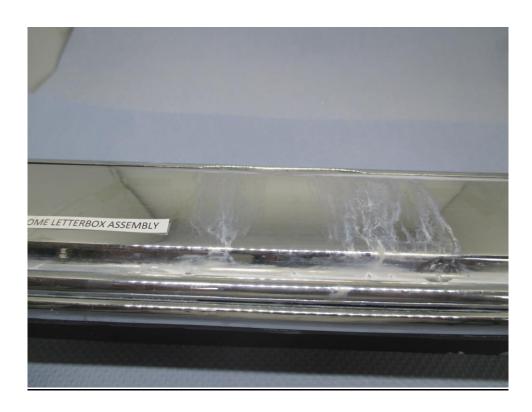
<u>FIG 8</u>

Photograph showing the condition of the Chrome Letterbox Assembly after 1008 hours Salt Spray Test
