Our Ref: GBW Number 19-01187-1 Issue 1 Date 08/03/2019 Page 1 of 7

A KENRICK & SONS LTD
Kenrick Way
West Bromwich
West Midlands
B70 6DB

SALT SPRAY TESTING OF DOOR HARDWARE SAMPLE

Description: 1 off. Gold Letterbox Assembly
Finish: PVD Coated / Zn Die Cast Substrate

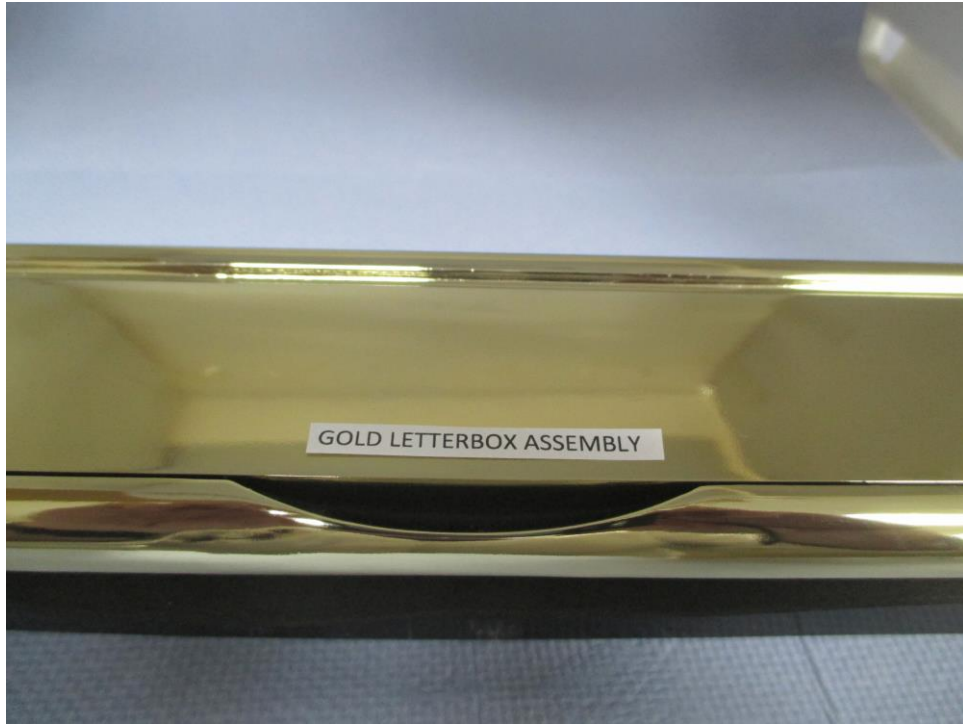
FIG 1

The photograph in fig 1 is showing the as- received condition of the sample prior to test, the sample was then exposed to a neutral 5% Salt Spray for a test period of 480 – 1008 hours with examinations after every 24 hours, revealed the following observations:-

Photograph showing the condition of the Gold Letterbox Assembly prior to Salt Spray Test

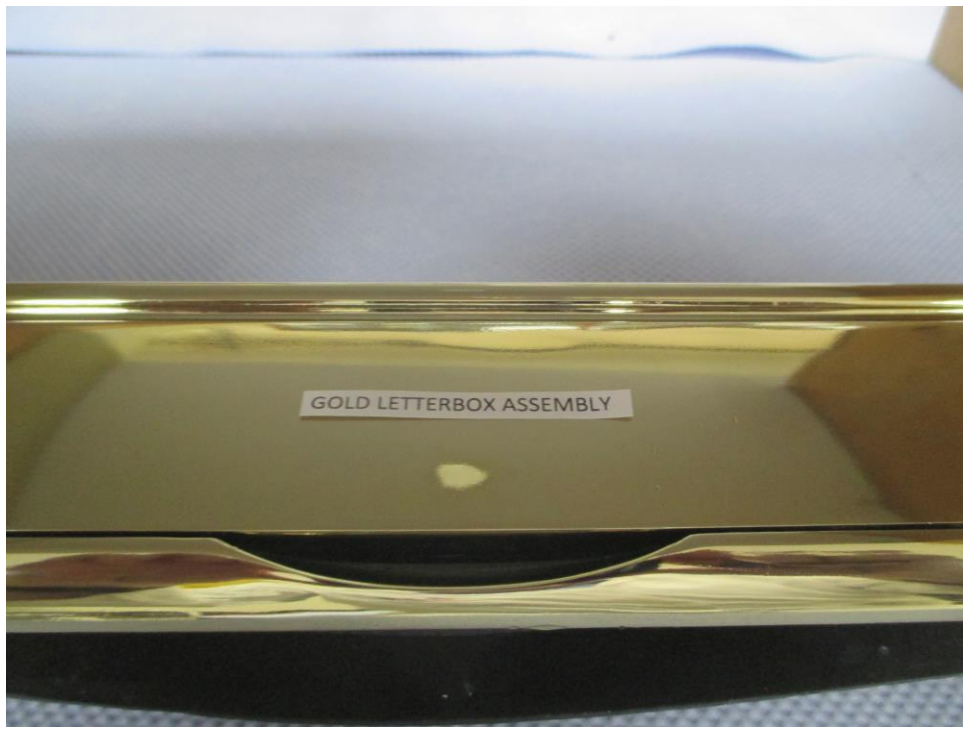
FIG 2

The flap section and outer frame section showed no evidence of corrosion product, (see photograph after 96 hours).

Photograph showing the condition of the Gold Letterbox Assembly after 96 hours Salt Spray Test

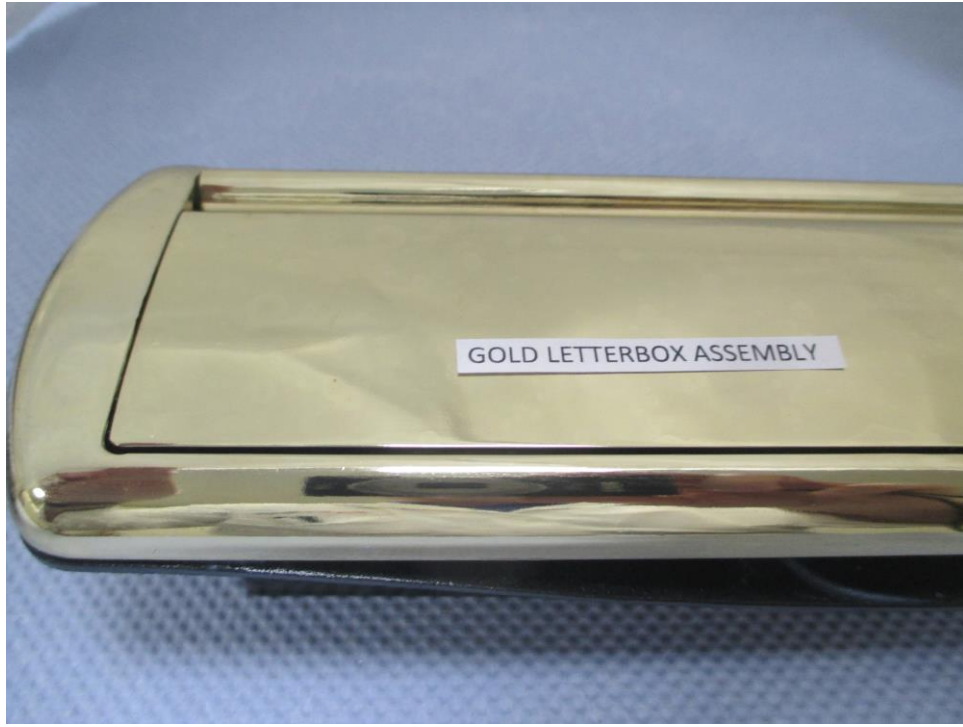
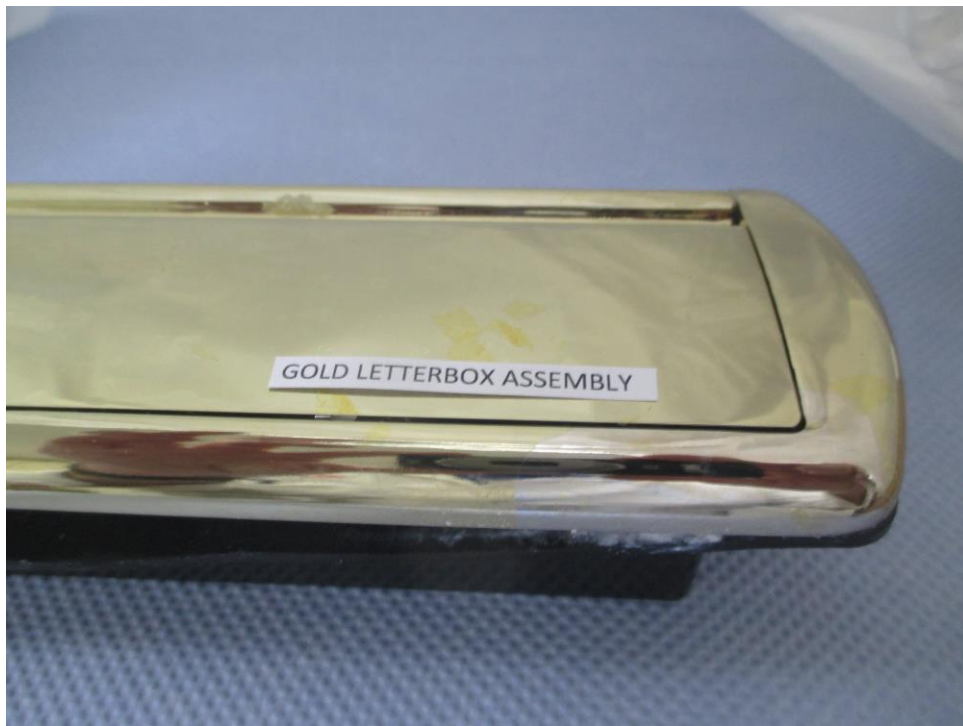
The outer frame section showed a slight amount of white corrosion product / staining from the bottom edge

The flap section and the outer frame section exhibited a moderate loss of the protective film, (see photographs after 264 hours).

The flap section and the outer frame section exhibited a loss of the protective film, however this is not classed as a corrosion, and however in our opinion with the protection coating film breakdown after 264 hours, it would be not considered cosmetically appealing.

Photograph showing the condition of the Gold Letterbox Assembly after 264 hours Salt Spray Test

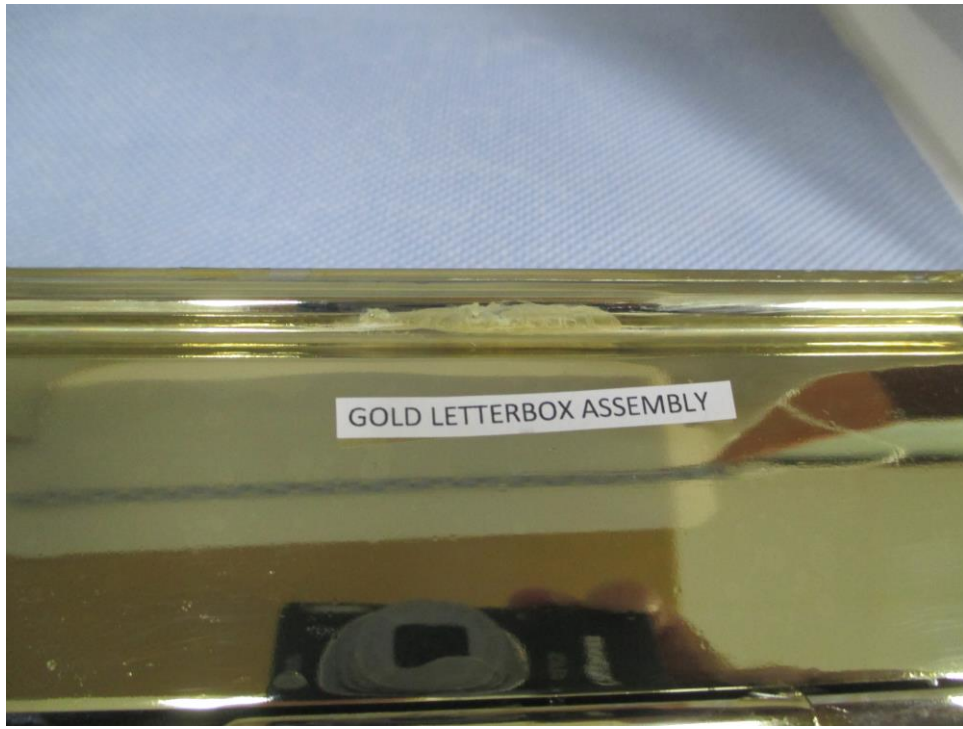
FIG 5

The flap section showed isolated corrosion spots and leaching white corrosion product / staining from the channel recesses less than 1.5mm.

The outer frame section showed a slight / moderate amount of white corrosion product / staining from the end interface joint, the flap section and the outer frame section exhibited a significant loss of the protective film, (see photograph after 480 hours).

The finish applied to the Gold Letterbox Assembly (Appearance) tested, **satisfied** 480 hours Salt Spray Test Requirement to British Standard Specification, BS EN.1670:2007, Grade 5.

Photograph showing the condition of the Gold Letterbox Assembly after 480 hours Salt Spray Test

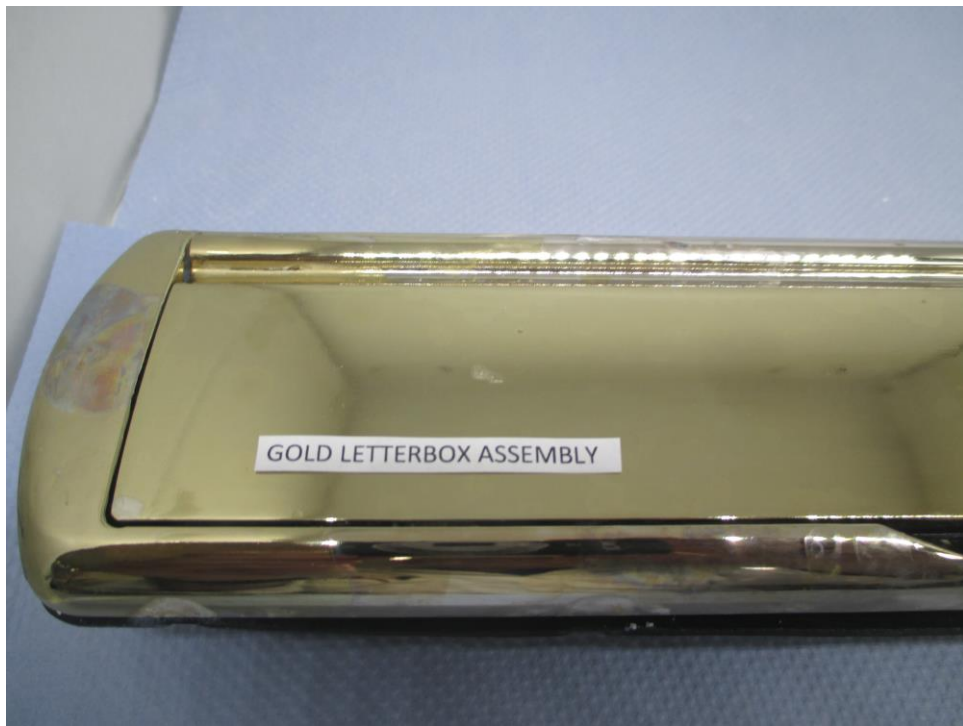
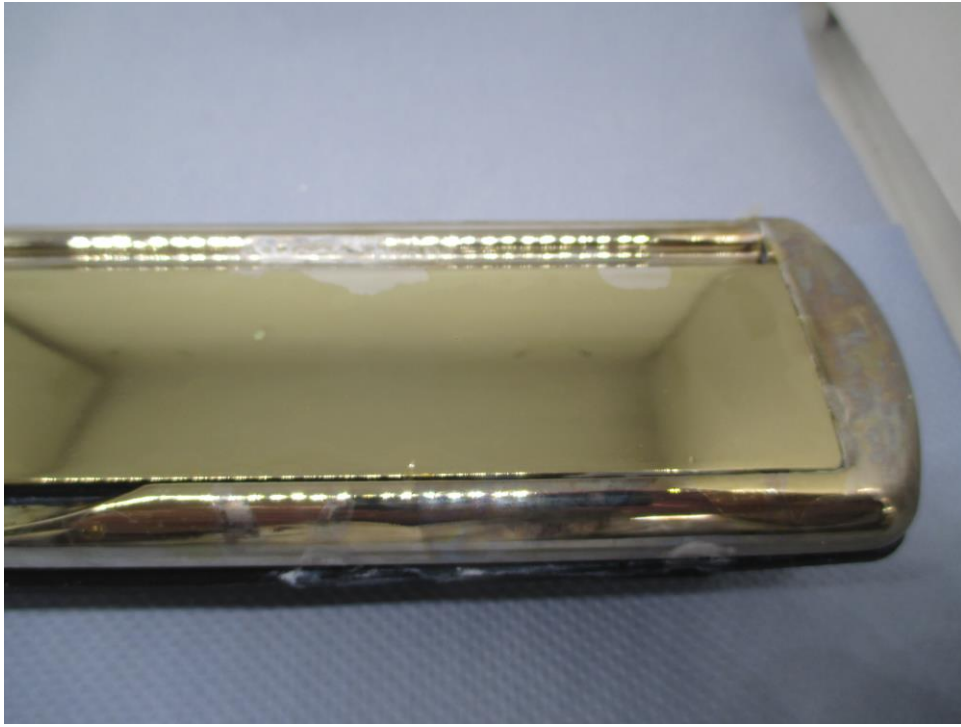
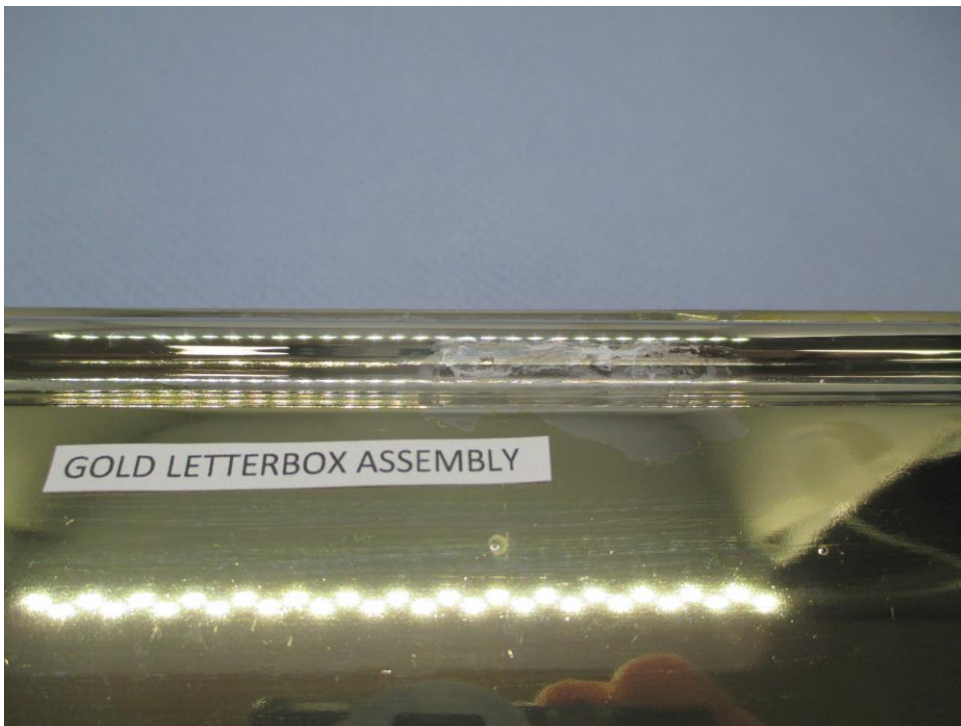
The flap sample showed evidence of 3 x corrosion spots (2.0mm Ø) and leaching white corrosion product / staining from the small channel recess and the top edge and 1 x corrosion spot (3.0mm Ø) and leaching white corrosion product / staining from the large channel recess, the significant surface of the flap sample showed a slight amount of small corrosion spots (0.50mm Ø).

The outer frame sample showed a moderate amount of white corrosion product / staining from the end interface joint, the outer frame edges showed white corrosion product / staining from the underside of the sample.

The significant surfaces exhibited significant loss of the protective film, (see photographs after 1008 hours).

Photograph showing the condition of the Gold Letterbox Assembly after 1008 hours Salt Spray Test
