Our Ref: GBW Number 19-01187 Issue 1 Date 08/03/2019 Page 1 of 7

A KENRICK & SONS LTD
Kenrick Way
West Bromwich
West Midlands
B70 6DB

SALT SPRAY TESTING OF DOOR HARDWARE SAMPLE

Description: 1 off. Bronze Letterbox Assembly
Finish: Lacquered Bronze Coated / Zn Die Cast Substrate

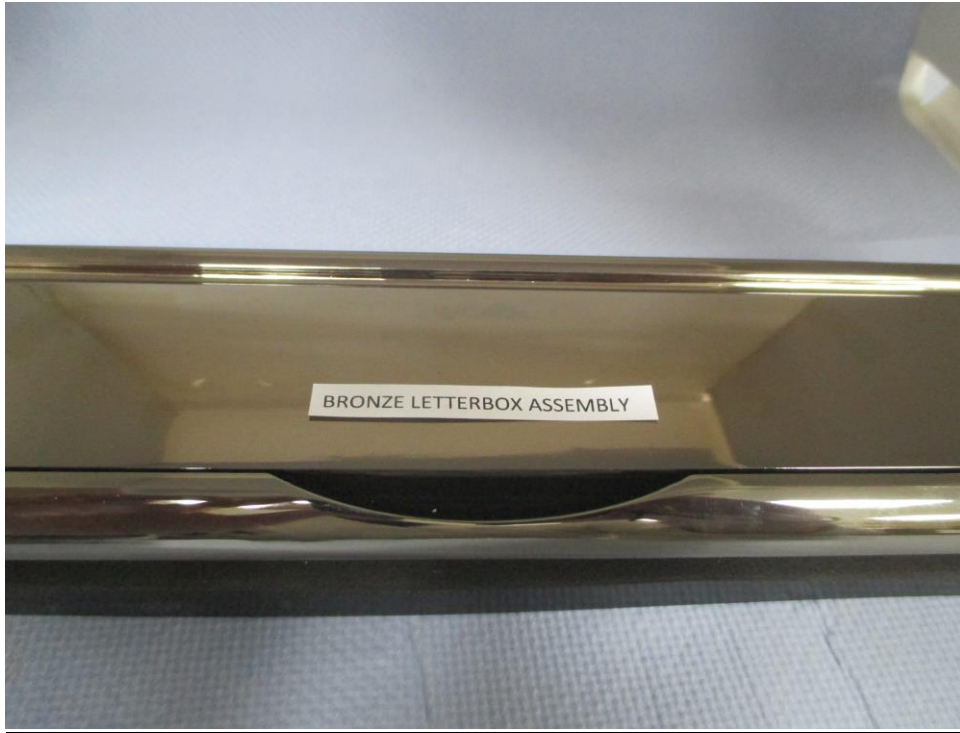
FIG 1

The photograph in fig 1 is showing the as- received condition of the sample prior to test, the sample was then exposed to a neutral 5% Salt Spray for a test period of 480 – 1008 hours with examinations after every 24 hours, revealed the following observations:-

Photograph showing the condition of the Bronze Letterbox Assembly prior to Salt Spray Test

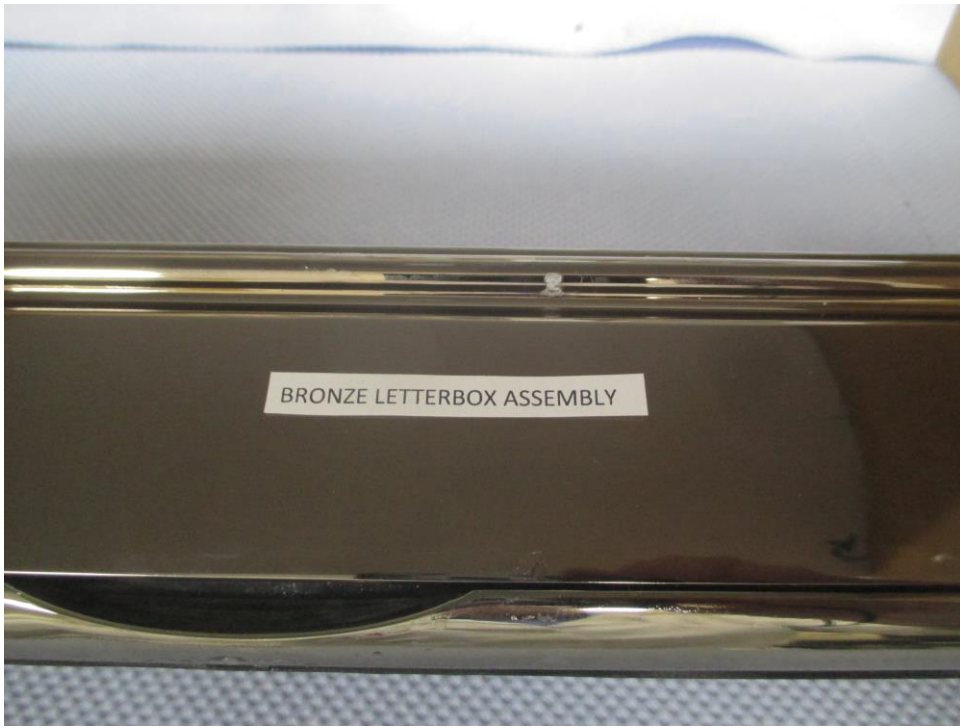
FIG 2

The flap section showed isolated corrosion spots and leaching white corrosion product / staining from the channel recesses.

The outer frame section showed a very slight amount of white corrosion product / staining from the end interface joint, (see photograph after 96 hours).

Photograph showing the condition of the Bronze Letterbox Assembly after 96 hours Salt Spray Test

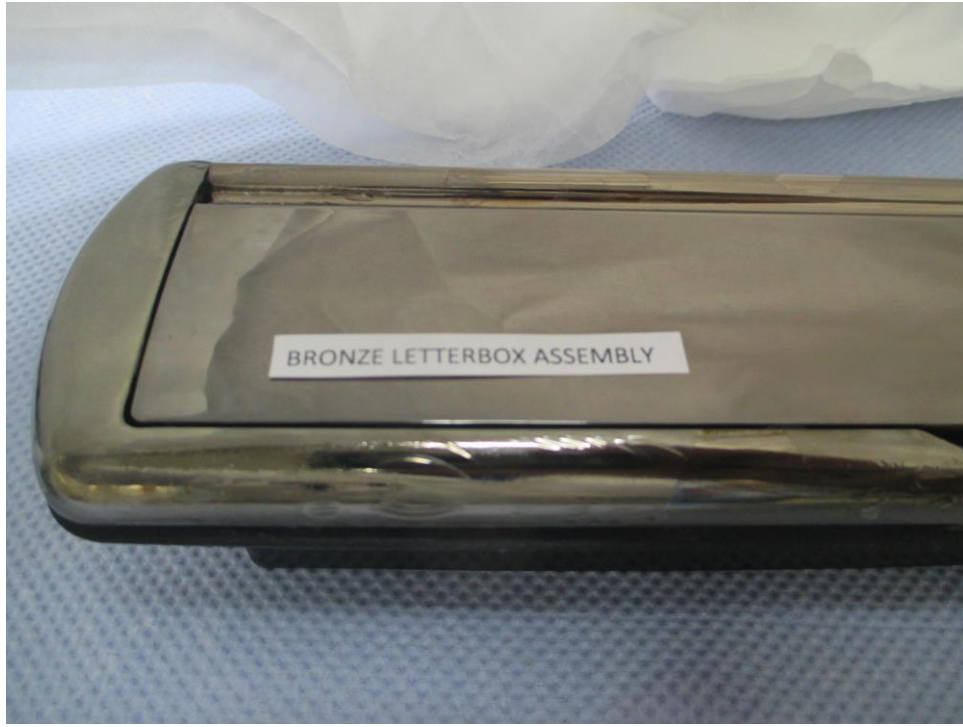
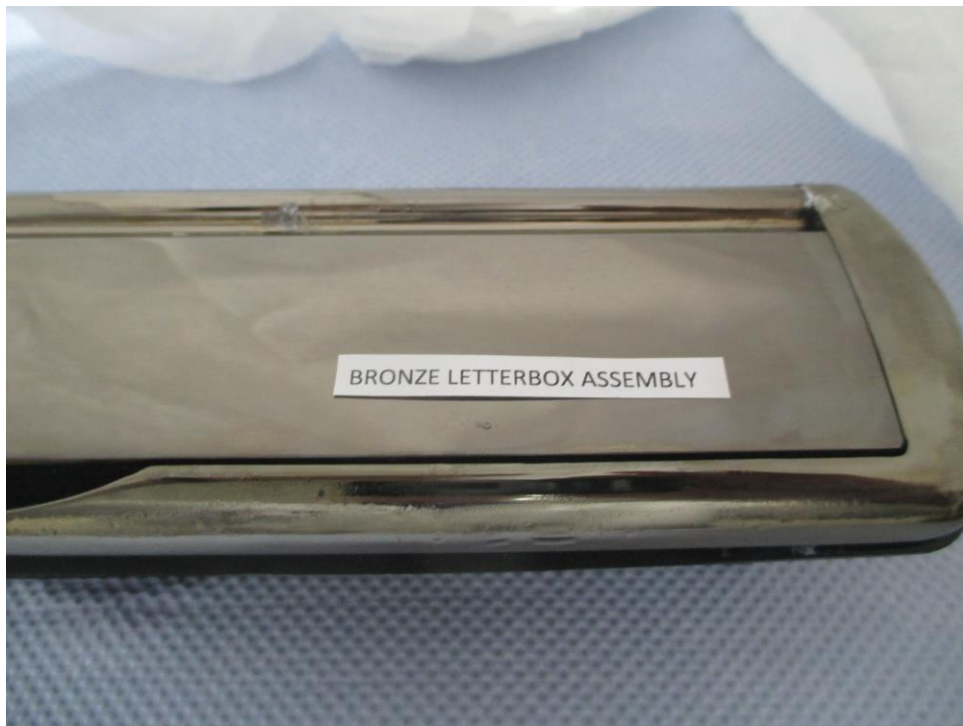
The flap section showed isolated corrosion spots and leaching white corrosion product / staining from the channel recesses.

The outer frame section showed a slight amount of white corrosion product / staining from the end interface joint, the flap section and the outer frame section exhibited a moderate loss of the protective film, (see photographs after 264 hours).

The flap section and the outer frame section exhibited a loss of the protective film, however this is not classed as a corrosion, and however in our opinion with the protection coating film breakdown after 264 hours, it would be not considered cosmetically appealing.

Photograph showing the condition of the Bronze Letterbox Assembly after 264 hours Salt Spray Test

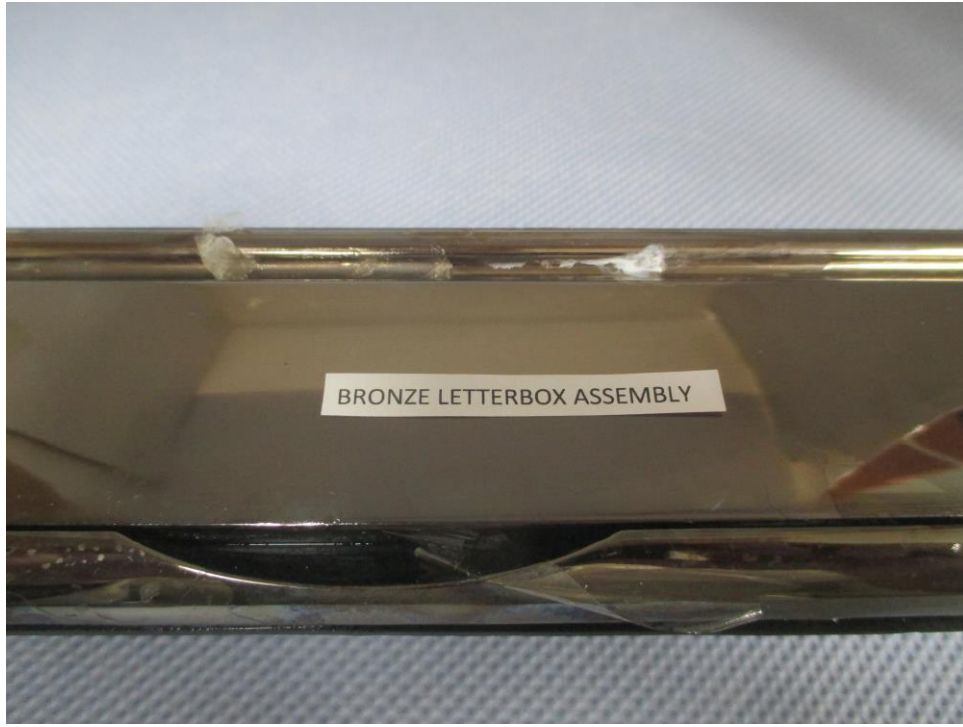
FIG 5

The flap section showed isolated corrosion spots and leaching white corrosion product / staining from the channel recesses less than 1.5mm.

The outer frame section showed a slight / moderate amount of white corrosion product / staining from the end interface joint, the flap section and the outer frame section exhibited a significant loss of the protective film, (see photograph after 480 hours).

Photograph showing the condition of the Bronze Letterbox Assembly after 480 hours Salt Spray Test

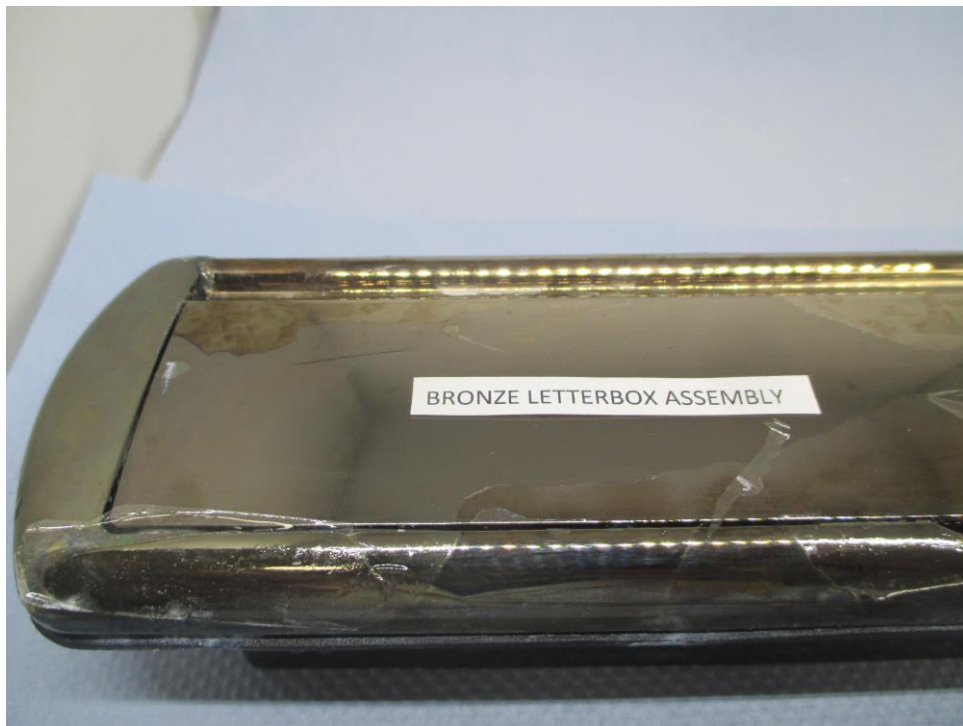
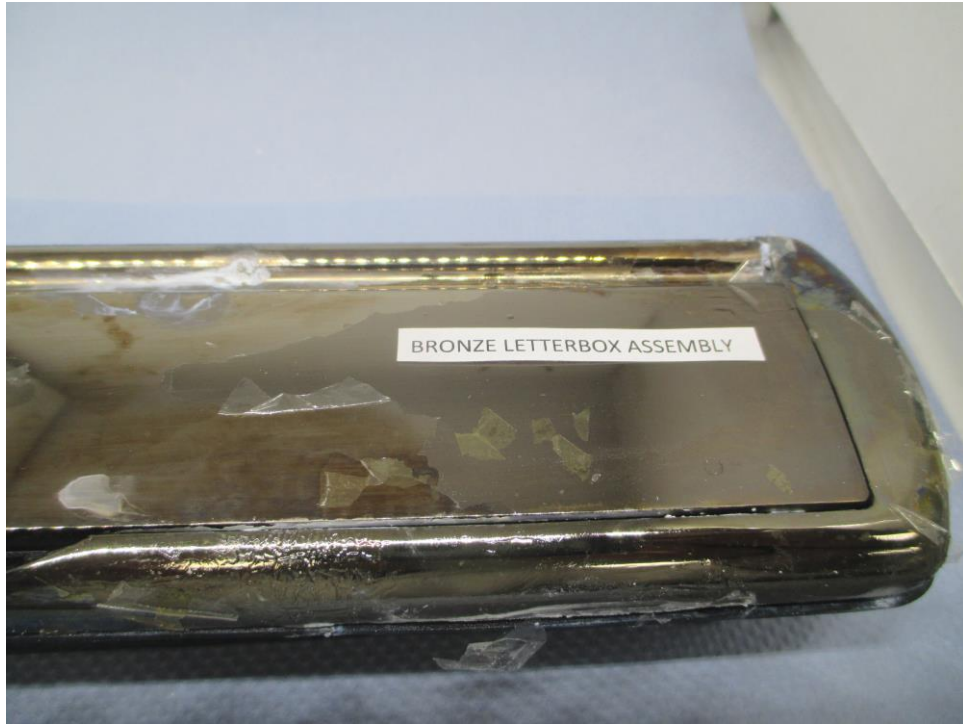
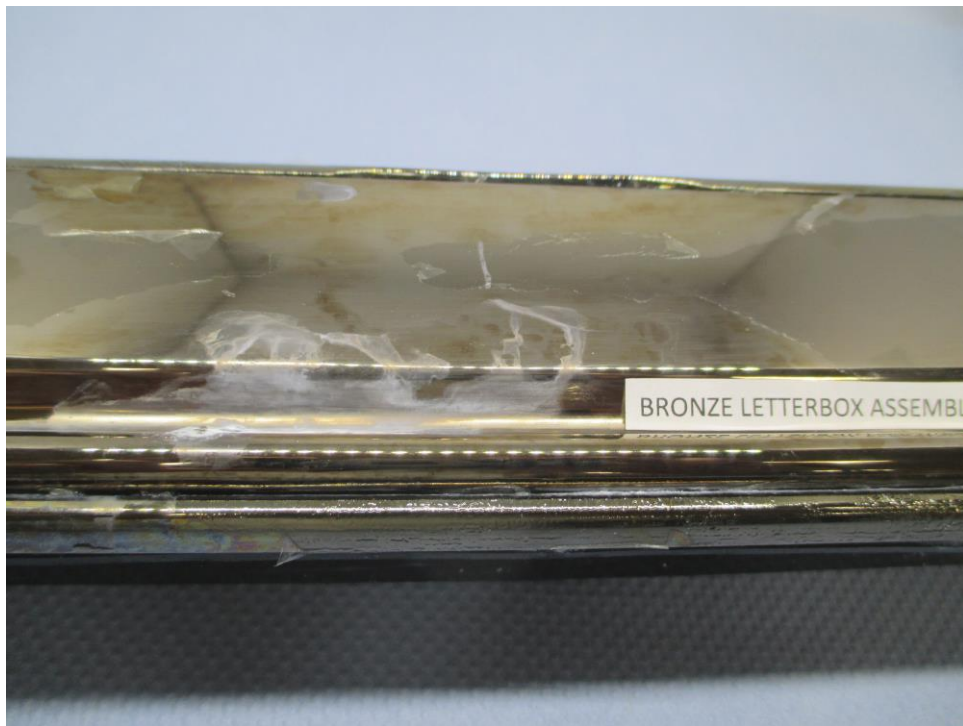
The flap sample showed evidence of 2 x corrosion spots (2.0mm Ø) and leaching white corrosion product / staining from the small channel recess and 1 x corrosion spot (4.0mm Ø) and leaching white corrosion product / staining from the large channel recess.

The outer frame sample showed a moderate amount of white corrosion product / staining from the end interface joint, the outer frame edges showed white corrosion product / staining from the underside of the sample.

The significant surfaces exhibited an excessive loss of the protective film, (see photographs after 1008 hours).

Photograph showing the condition of the Bronze Letterbox Assembly after 1008 hours Salt Spray Test
