Test Report

Our Ref: GBW Number 19-01187-4 Issue 1 Date 08/03/2019 Page 1 of 6

Tested For:- A KENRICK & SONS LTD

### SALT SPRAY TESTING OF DOOR HARDWARE SAMPLE

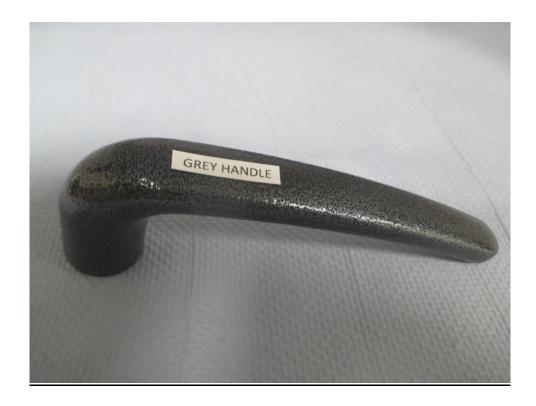
<u>FIG 1</u>

The photograph in fig 1 is showing the as-received condition of the sample prior to test, the sample was then exposed to a neutral 5% Salt Spray for a test period of 480 - 1008 hours with examinations after every 24 hours, revealed the following observations:-

Note: Prior to test a small area of damage was noticed on the under neck side of the handle, this area will be highlighted in this test report, however it will not form part of the final assessment.

Photograph showing the condition of the Grey Handle Sample prior to Salt Spray Test

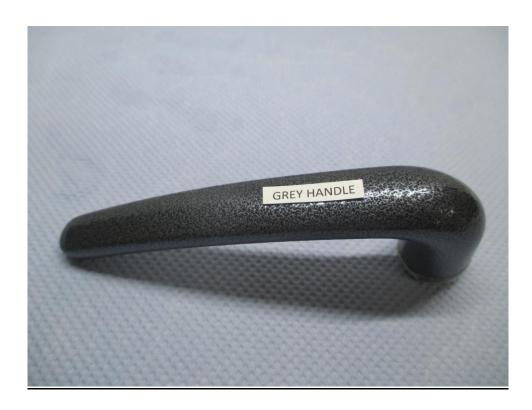
<u>FIG 2</u>

The sample showed no evidence of corrosion product or blistering, (see photograph after 96 hours).

Photograph showing the condition of the Grey Handle Sample after 96 hours Salt Spray Test

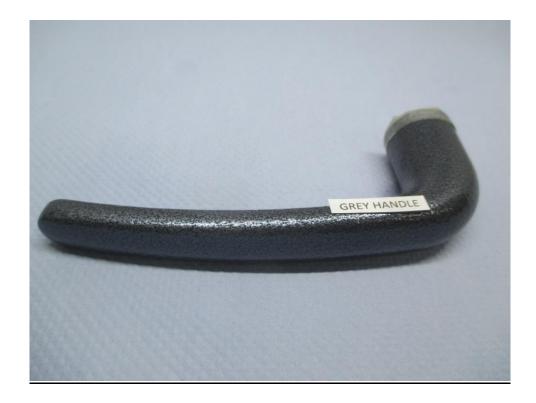
<u>FIG 3</u>

The sample showed no evidence of corrosion product or blistering, (see photograph after 264 hours).

Photograph showing the condition of the Grey Handle Sample after 264 hours Salt Spray Test

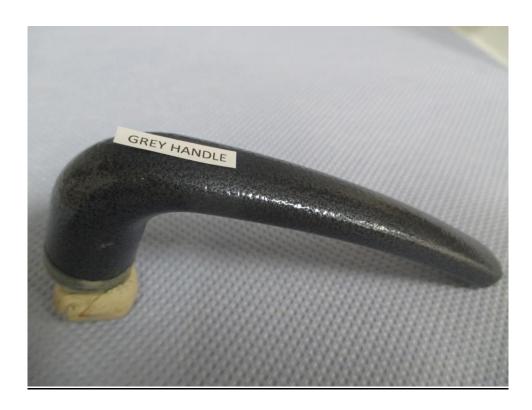
<u>FIG 4</u>

The sample showed no evidence of corrosion product or blistering, the damaged area showed slight white corrosion product, (see photograph after 480 hours).

Photograph showing the condition of the Grey Handle Sample after 480 hours Salt Spray Test

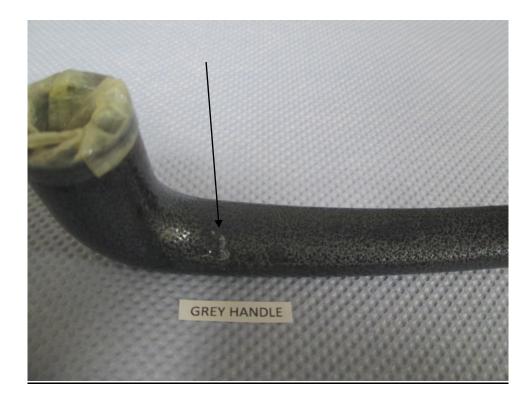
<u>FIG 5</u>

Photograph showing the condition of the Grey Handle Sample after 480 hours Salt Spray Test (Damaged area)

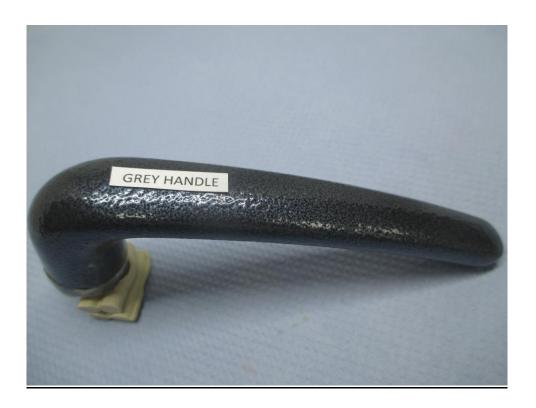
<u>FIG 6</u>

The sample showed no evidence of corrosion product or blistering, the damaged area showed slight white corrosion product / staining and small blister cluster, (see photographs after 1008 hours).

The finish applied to the Grey Handle Sample (Appearance) tested, <u>satisfied</u> 480 hours Salt Spray Test Requirement to British Standard Specification, BS EN.1670:2007, Grade 5.

Photograph showing the condition of the Grey Handle Sample after 1008 hours Salt Spray Test

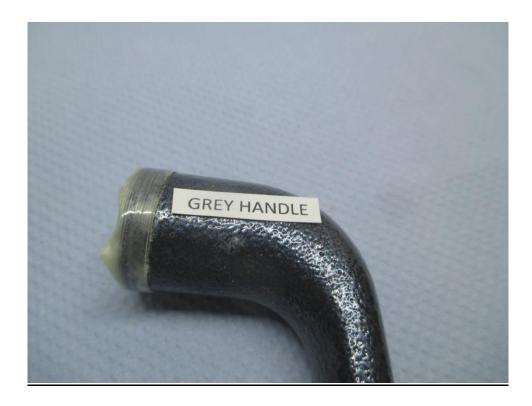
<u>FIG 7</u>

Photograph showing the condition of the Grey Handle Sample after 1008 hours Salt Spray Test

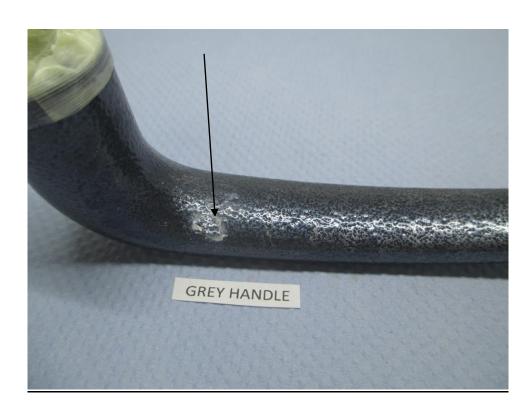
FIG 8

Photograph showing the condition of the Grey Handle Sample after 1008 hours Salt Spray Test (Damaged area)
