Our Ref: GBW Number 19-01187-6 Issue 1 Date 08/03/2019 Page 1 of 5

A KENRICK & SONS LTD
Kenrick Way
West Bromwich
West Midlands
B70 6DB

SALT SPRAY TESTING OF DOOR HARDWARE SAMPLE

Description: 1 off. White Handle Sample
Finish: White Powdercoat / Zn Die Cast Substrate

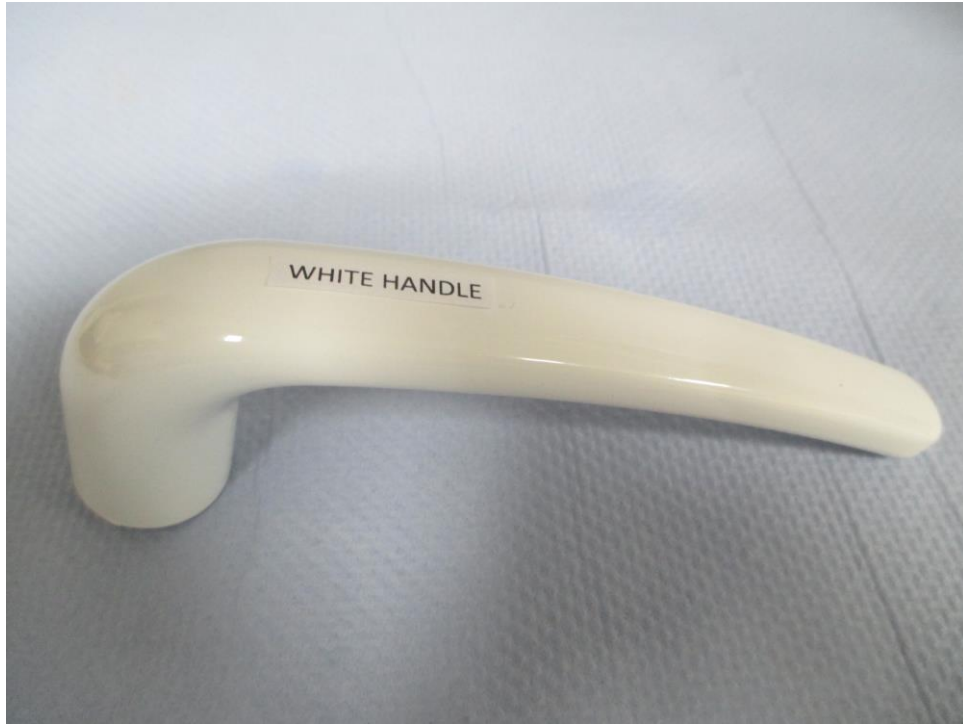
FIG 1

Photograph showing the condition of the White Handle Sample prior to Salt Spray Test

The photograph in fig 1 is showing the as- received condition of the sample prior to test, the sample was then exposed to a neutral 5% Salt Spray for a test period of 480 – 1008 hours with examinations after every 24 hours, revealed the following observations:-

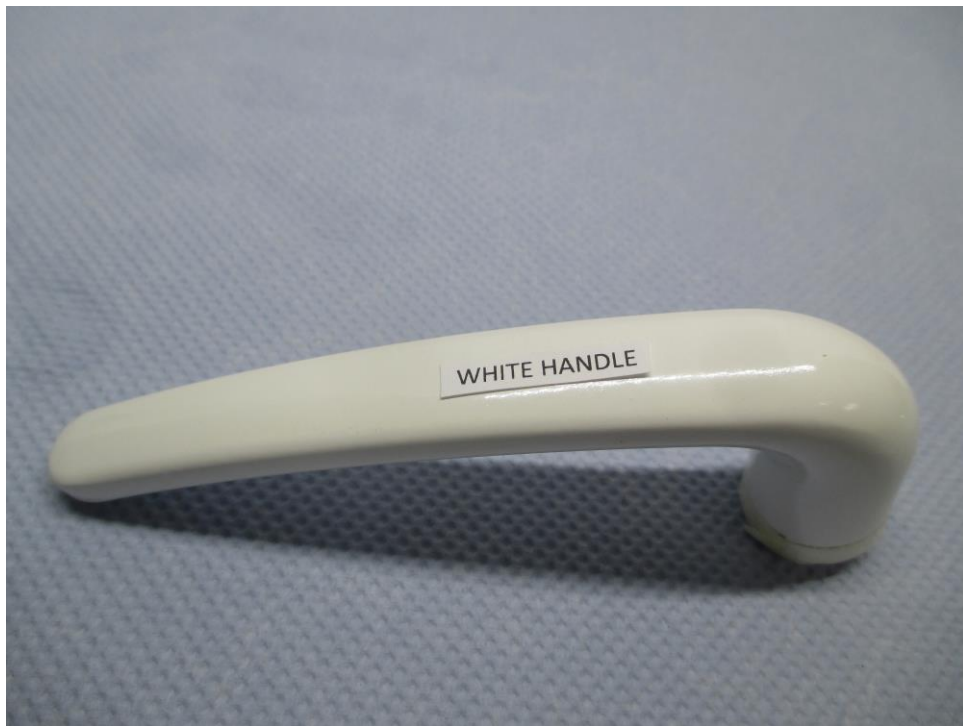
FIG 2

The sample showed no evidence of corrosion product or blistering, (see photograph after 96 hours).

Photograph showing the condition of the White Handle Sample after 96 hours Salt Spray Test

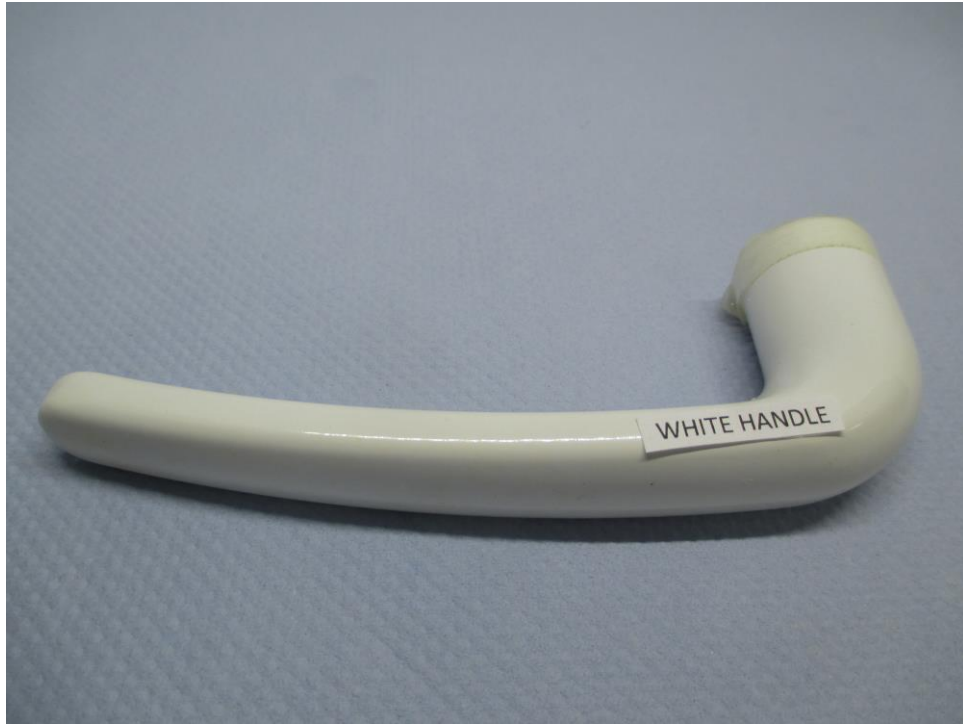
FIG 3

The sample showed no evidence of corrosion product or blistering, (see photograph after 264 hours).

Photograph showing the condition of the White Handle Sample after 264 hours Salt Spray Test

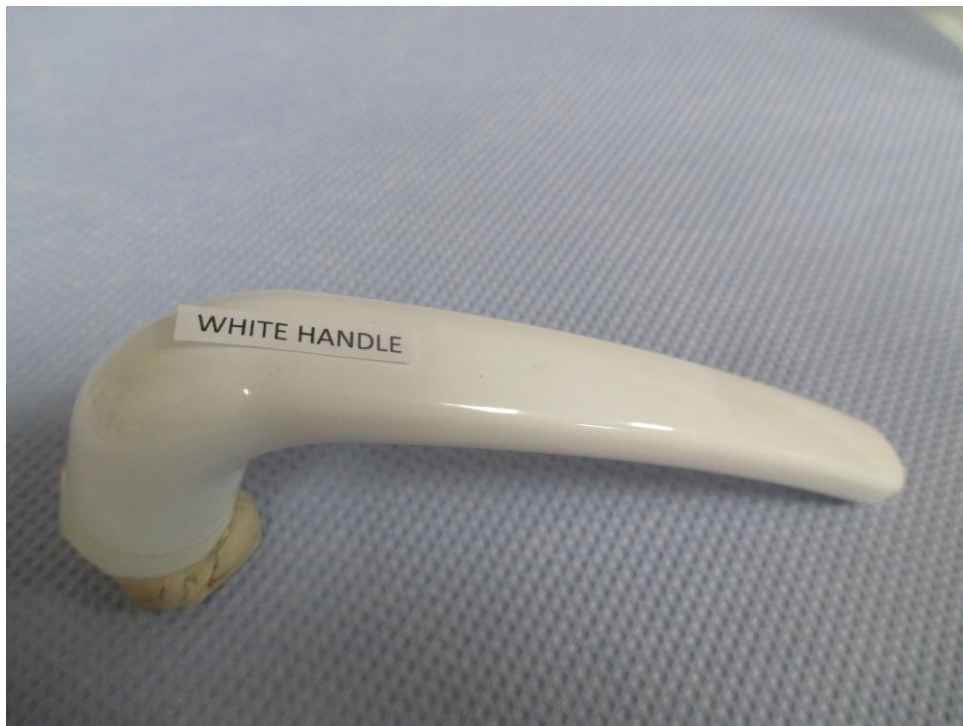
FIG 4

The sample showed no evidence of corrosion product or blistering, (see photograph after 480 hours).

Photograph showing the condition of the White Handle Sample after 480 hours Salt Spray Test

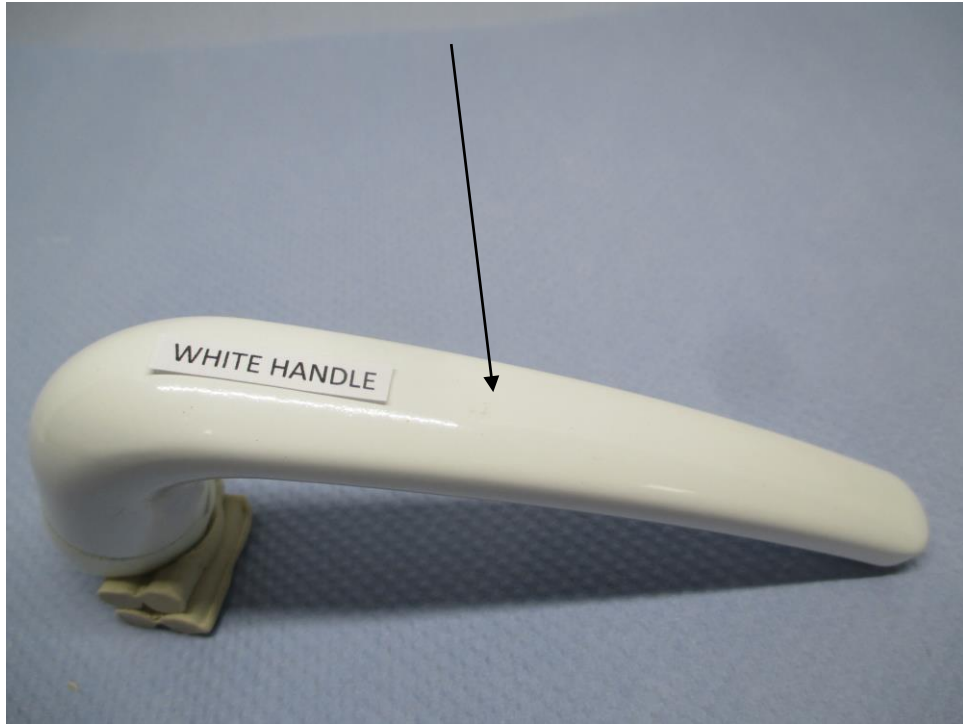
FIG 5

Photograph showing the condition of the White Handle Sample after 480 hours Salt Spray Test

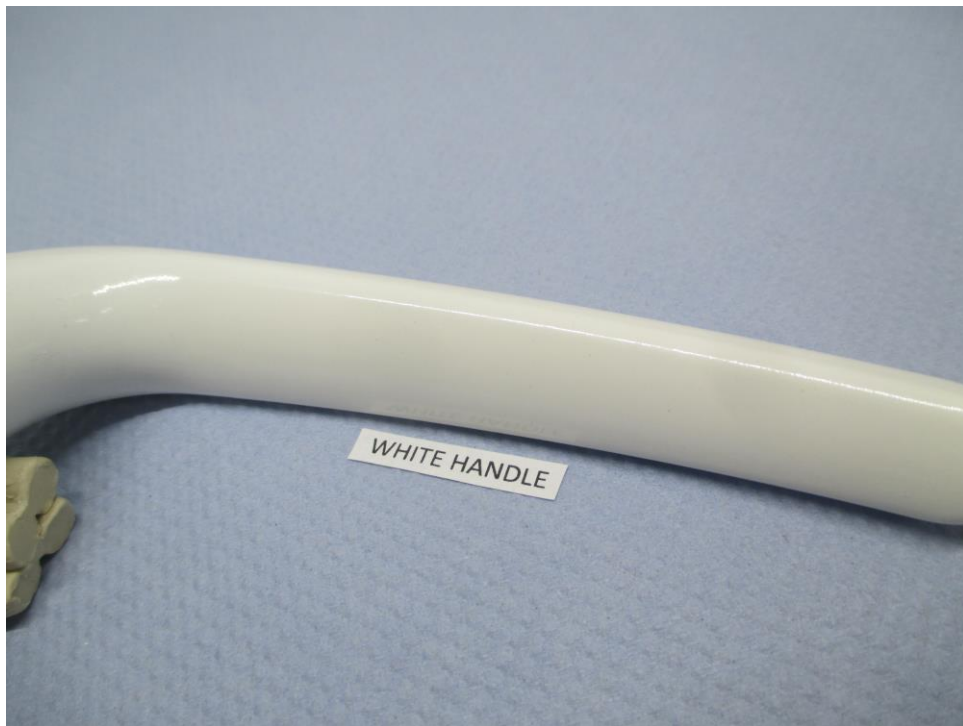
FIG 6

The sample showed 1 x small corrosion spot (3.0mmØ) leaching white corrosion product / staining from the top and a slight amount small corrosion spots (0.5mmØ) over the sample, (see photographs after 1008 hours).

The finish applied to the White Handle Sample (Appearance) tested, **satisfied** 480 hours Salt Spray Test Requirement to British Standard Specification, BS EN.1670:2007, Grade 5.

Photograph showing the condition of the White Handle Sample after 1008 hours Salt Spray Test
